# PERFORMANCE OF AN ENGINEERED COVER SYSTEM FOR A URANIUM MINE WASTE ROCK PILE IN NORTHERN SASKATCHEWAN AFTER SIX YEARS

## ABSTRACT

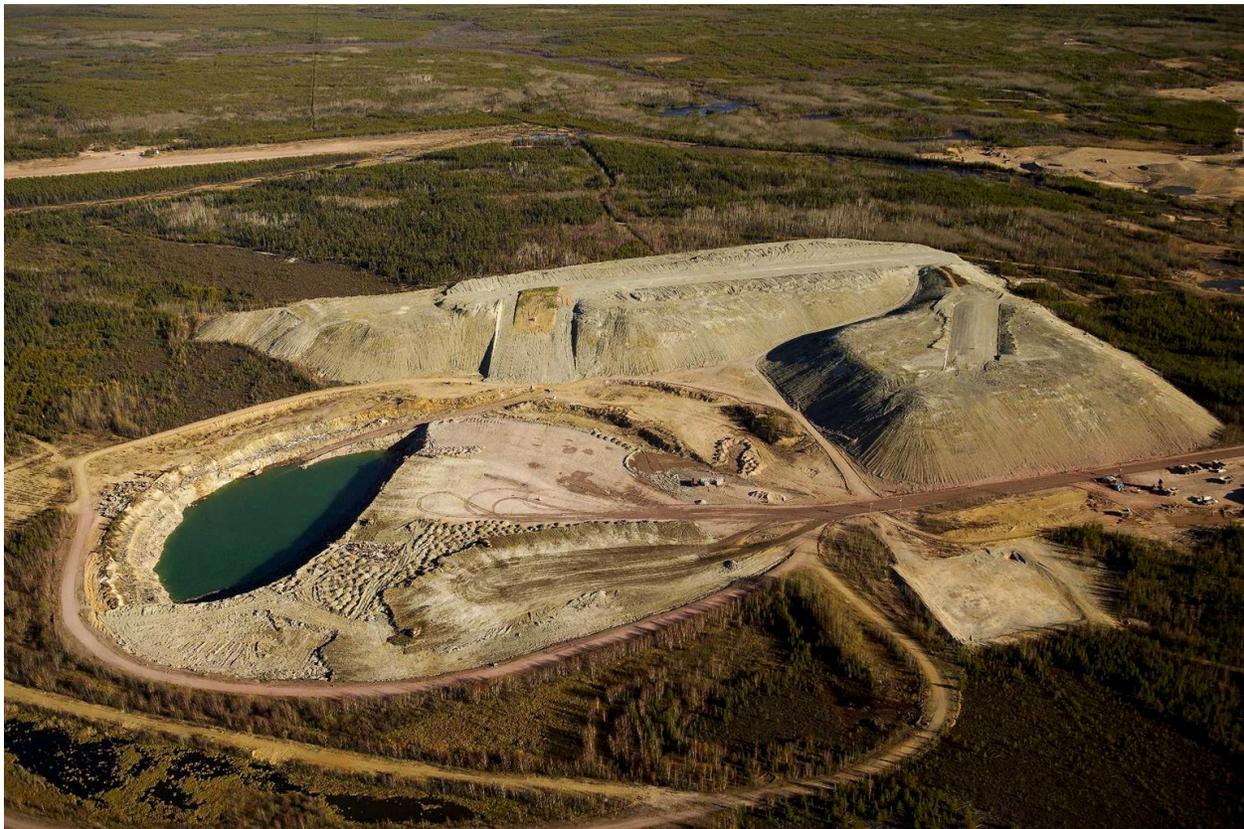
**Figure 1** Photo of the Claude waste rock pile in about 2003 prior to pile re-grading and cover system construction (Claude pit being backfilled in the foreground).

The Claude WRP was constructed between 1982 and 1989 and contains waste rock from the Claude pit. The pile is approximately 30 m high and covers an area of 26.4 hectares to the south of the Claude pit (see Figure 1). It contains approximately 7.23 million tonnes of waste, with an estimated volume of approximately 4.1 Mm<sup>3</sup> based on a dry density of 1,750 kg/m<sup>3</sup>.

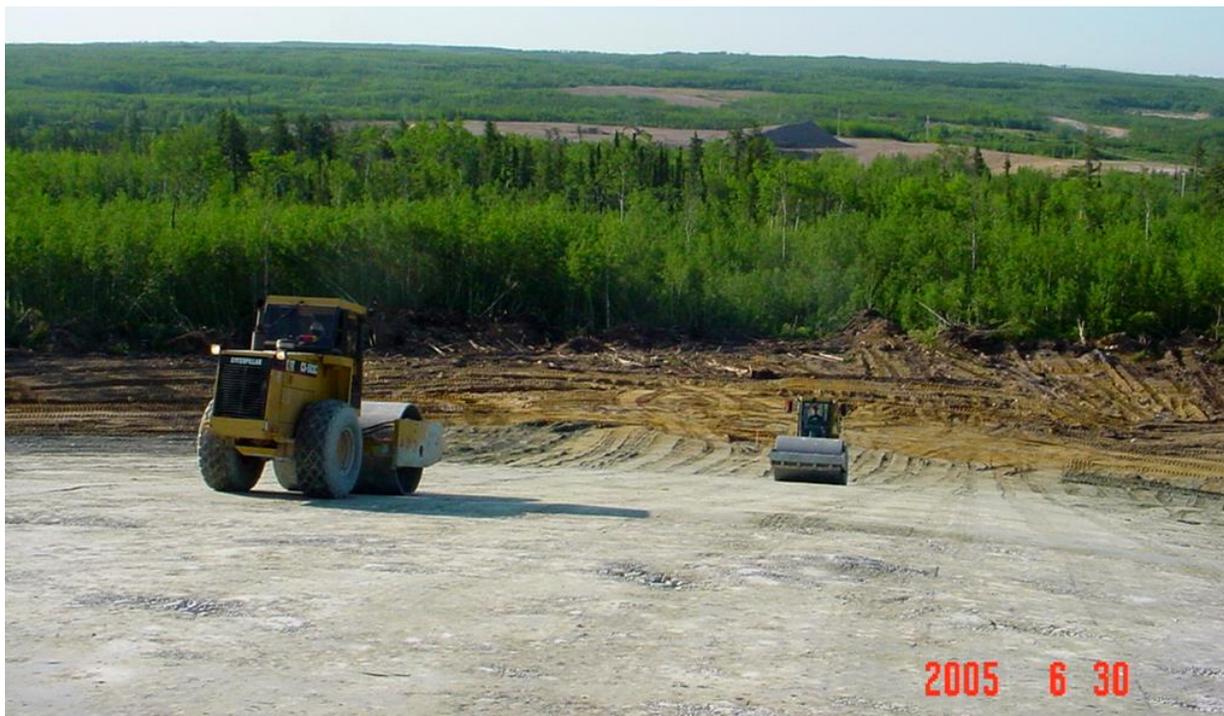
**Figure 2** Photo of the re-graded Claude WRP being compacted in 2005 prior to till cover placement.

Compaction of the waste rock surface was accomplished using a Caterpillar CS583 roller (AREVA, 2007). Generally, two passes were required to meet the required minimum dry density of 95% of Standard Proctor Maximum Dry Density. Due to the unseasonably wet weather encountered during the waste rock compaction effort, moisture conditioning was not required to achieve the specified density. In general, the majority of the re-graded waste rock surface contained sufficient fine-textured materials to produce a relatively smooth surface (see Figure 2). Areas of the WRP that were visually determined to be too open-graded were re-graded to blend in additional fines (with either waste rock or till) and re-compacted. The estimated field saturated hydraulic conductivity of the compacted waste rock layer is  $10^{-5}$  to  $10^{-6}$  cm/s.

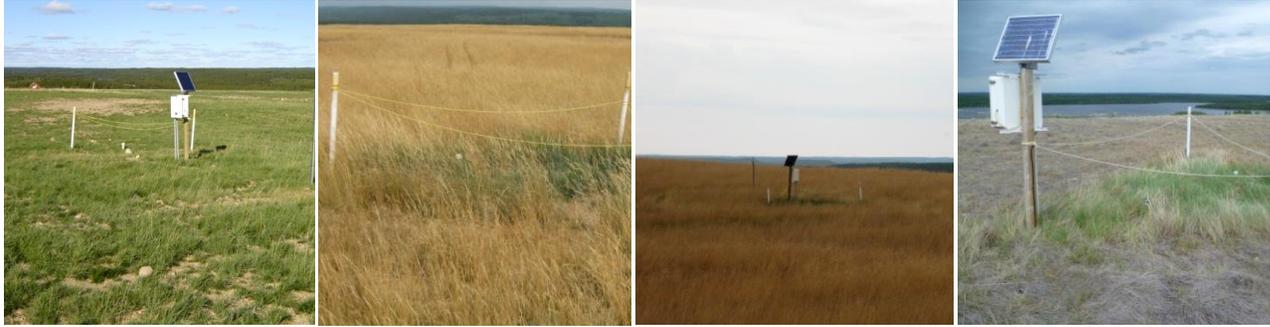
(a) August 2007 – Plateau Station

(b) July 2008 – Plateau Station

(c) September 2009 – Plateau Station

(d) June 2012 – Plateau Station

**Figure 5** Photos illustrating evolution of vegetation on the Claude WRP cover system.

Performance of the cover system will evolve over time in response to site-specific physical, chemical, and biological processes (INAP, 2003). Substantial growth of the various grass and legume species has occurred between August 2007 and June 2012 on the Claude pile cover system (Figure 5), with only minor observed erosion. A more mature vegetation cover will contribute to lower net percolation / seepage volumes through increased interception and transpiration rates.
